POST-RESTORATION EVALUATION OF TWO URBAN STREAMS IN AUSTIN,
TEXAS, USA

A Thesis

Major Subject: Water Management and Hydrological Sciences

Post-restoration Evaluation of Two Urban Streams in Austin, Texas, USA. (May 2008)

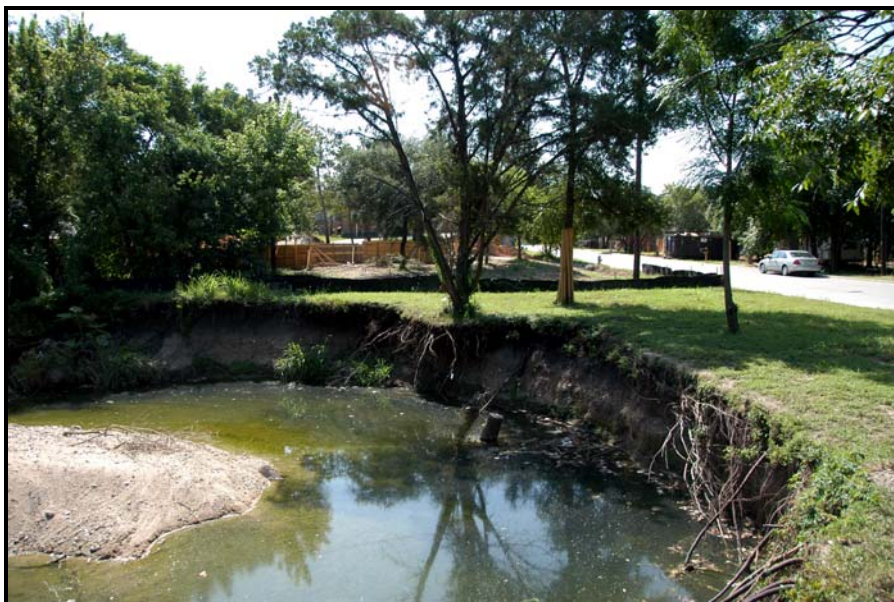
Figure 2. Tannehill Branch immediately upstream of Lovell Drive restoration site, March 2006.

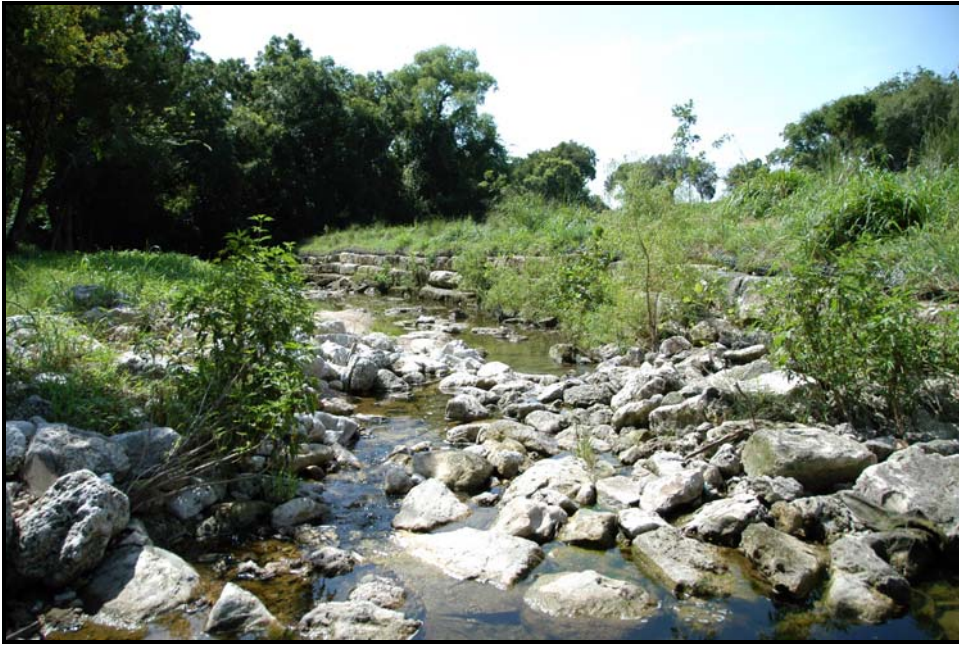
Figure 4. Example of limestone grade control structure at the Lovell Drive restoration project on Tannehill Branch, July 2007.

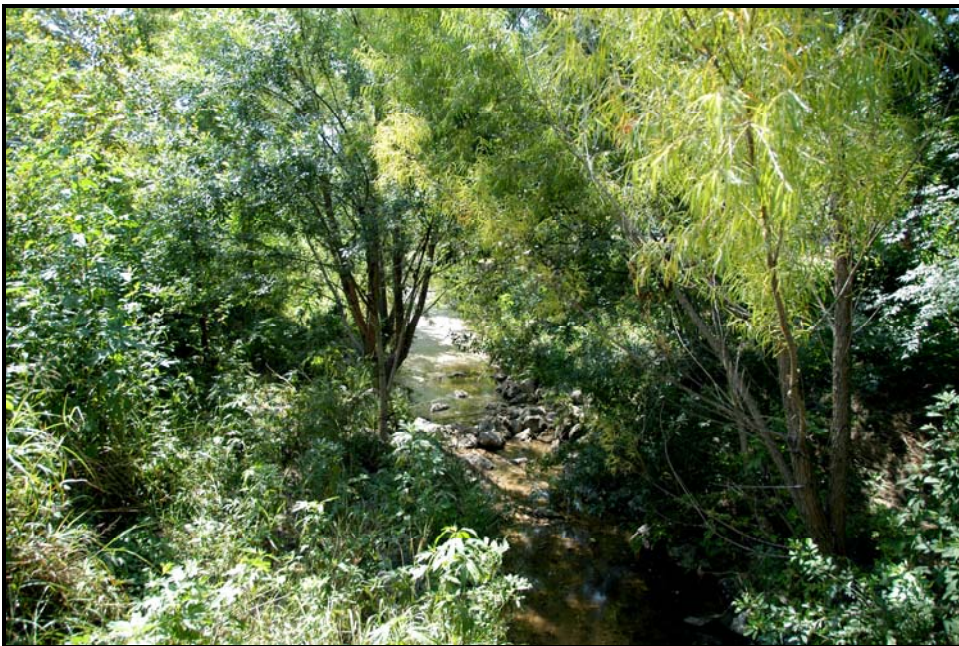
Figure 5. Native trees, shrubs, and grasses planted on the restored banks of Waller Creek in Shipe Park, July 2007.

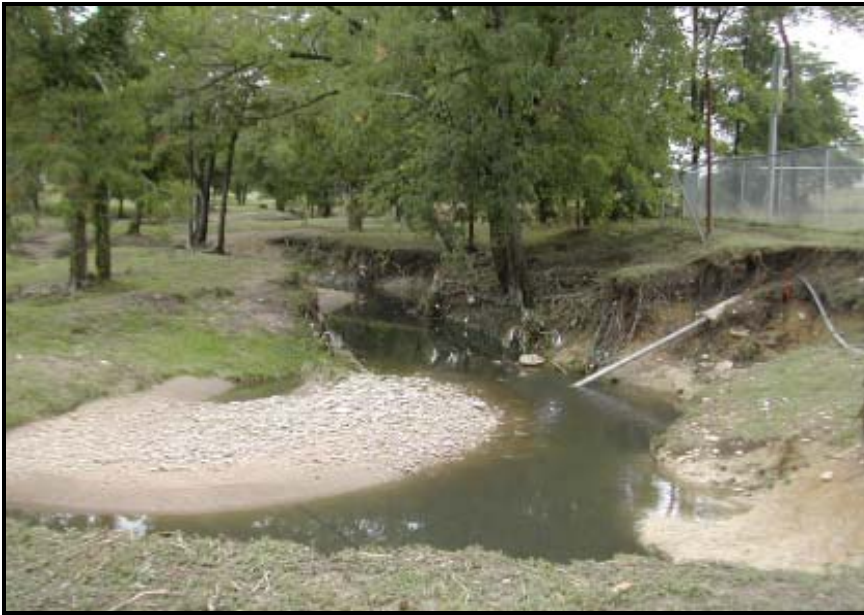
Figure 6. Tannehill Branch in Bartholomew Park, next to baseball fields, before restoration in 2003 (Courtesy M. Rotar).

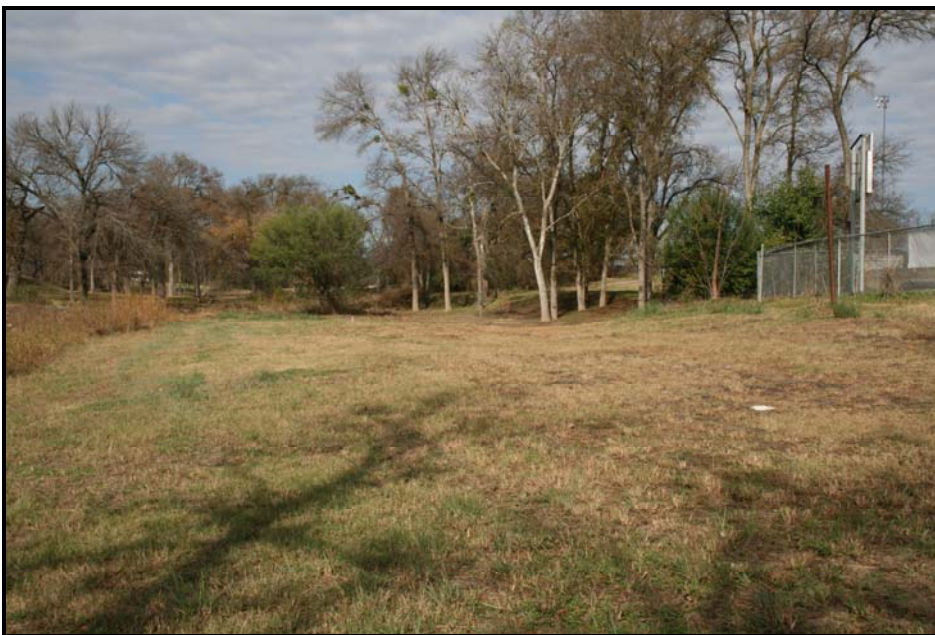
Figure 7. Tannehill Branch in Bartholomew Park, next to baseball fields, after restoration in 2007.

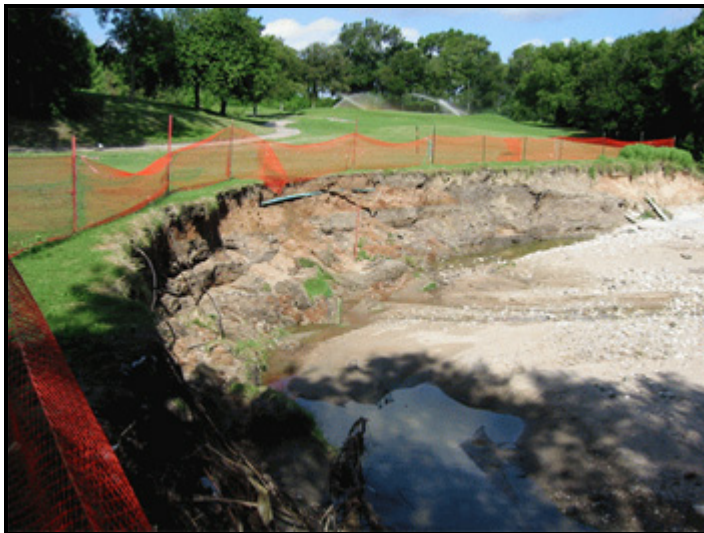
Figure 8. Tannehill Branch at Lovell Drive before restoration in 2005 (City of Austin, 2001a).

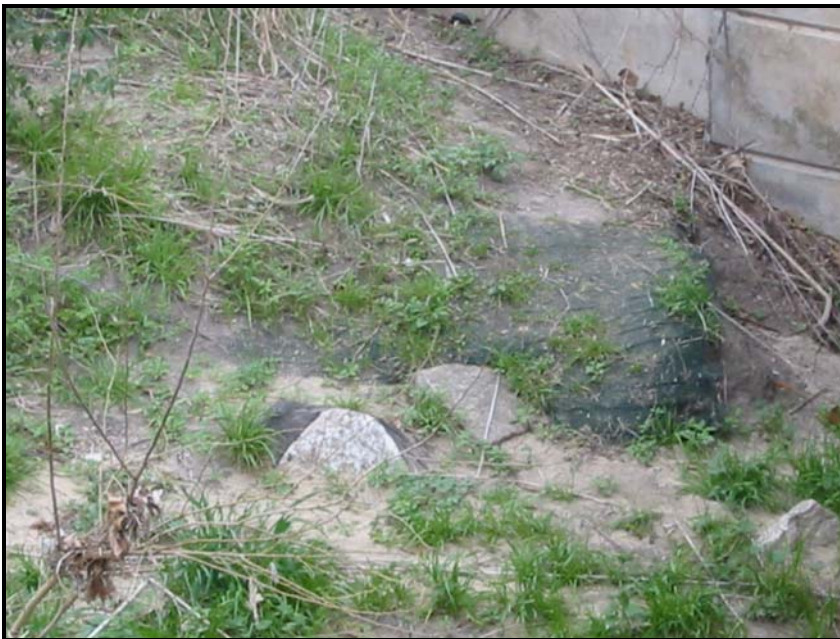
Figure 13. Erosion control blanket used to stabilize the banks of Waller Creek in Shipe Park, March 2007.

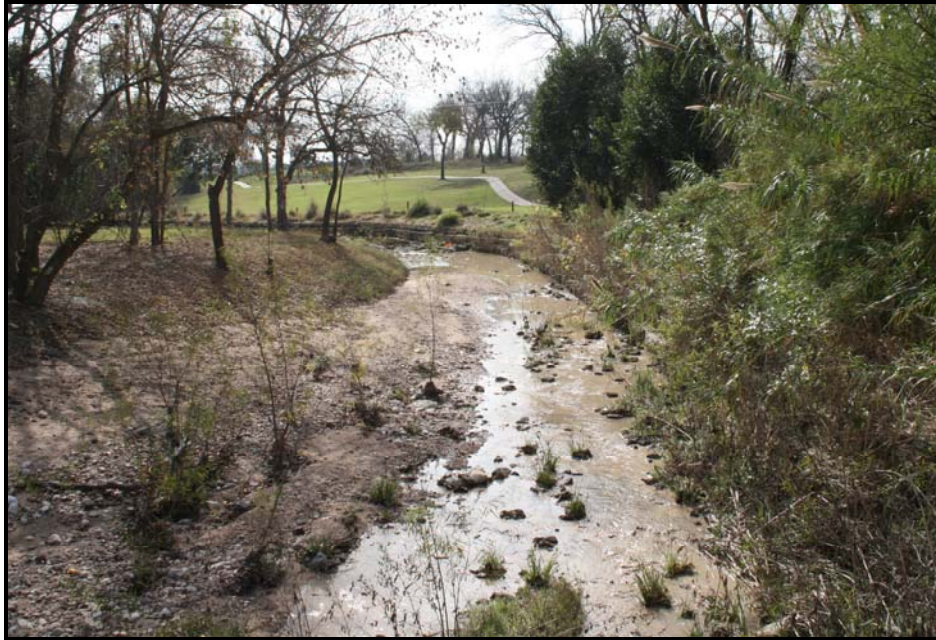
features have minimized erosion of the cut bank on this reach, they might also be the cause of excessive deposition of fine sediment in the bankfull channel (Figures 19 and 25).

Figure 25. Tannehill Branch facing downstream of Lovell Drive. Note sand bar along the left bank of the channel.

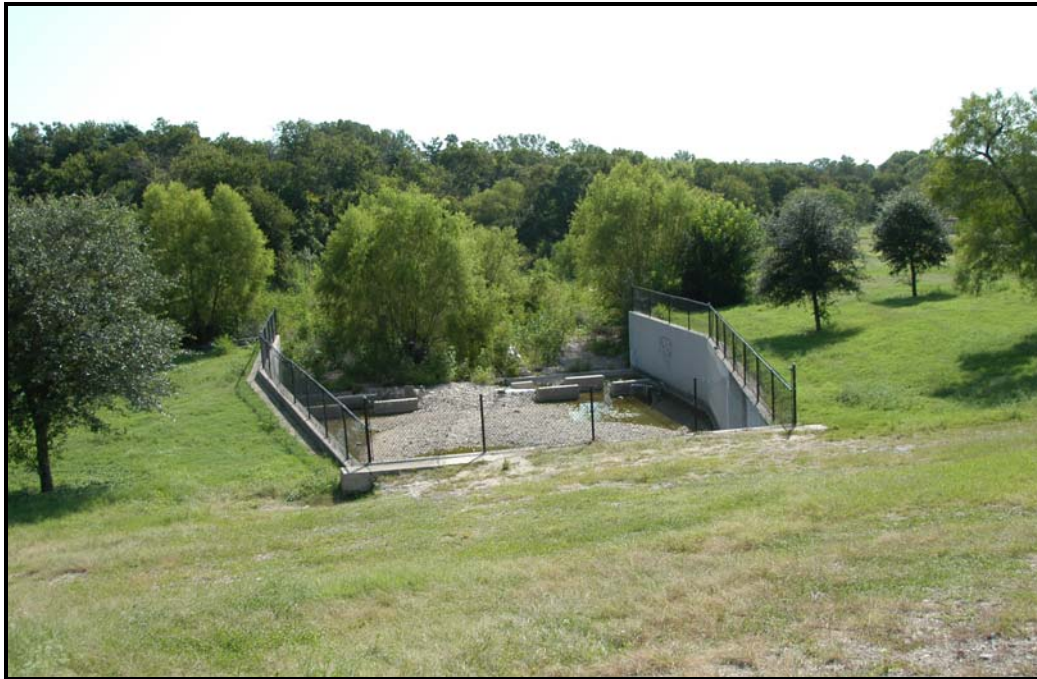
Figure 26. The flood control structure separating the western and eastern portions of the park. This photograph, taken in July 2007, faces downstream and shows the eastern portion of the park.

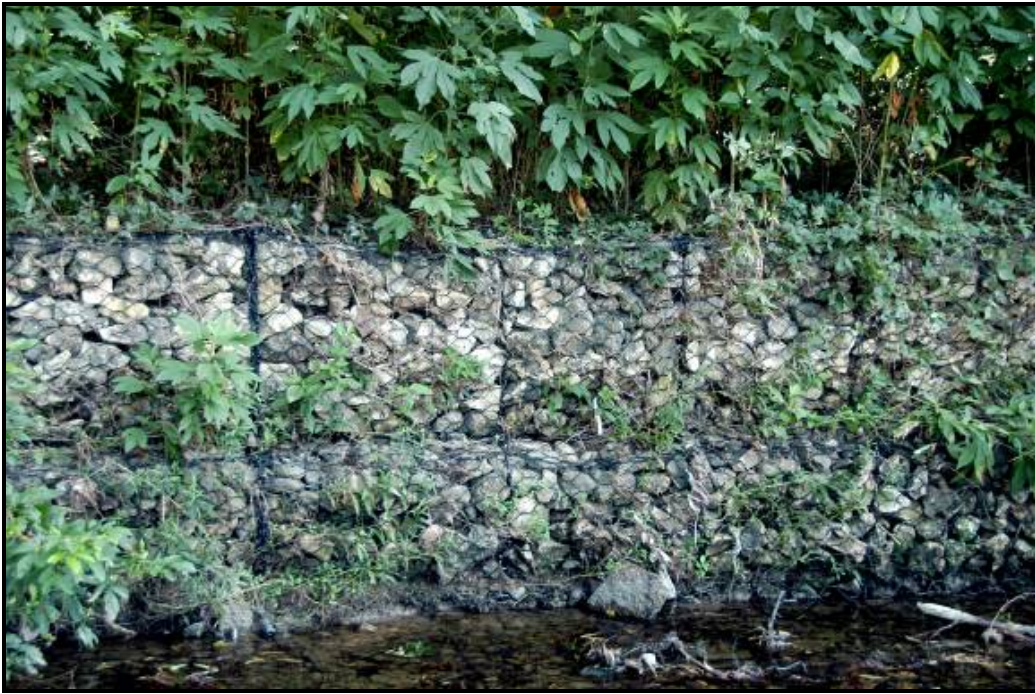
Figure 27. Example of traditional bank stabilization, rock filled gabions, July 2007.

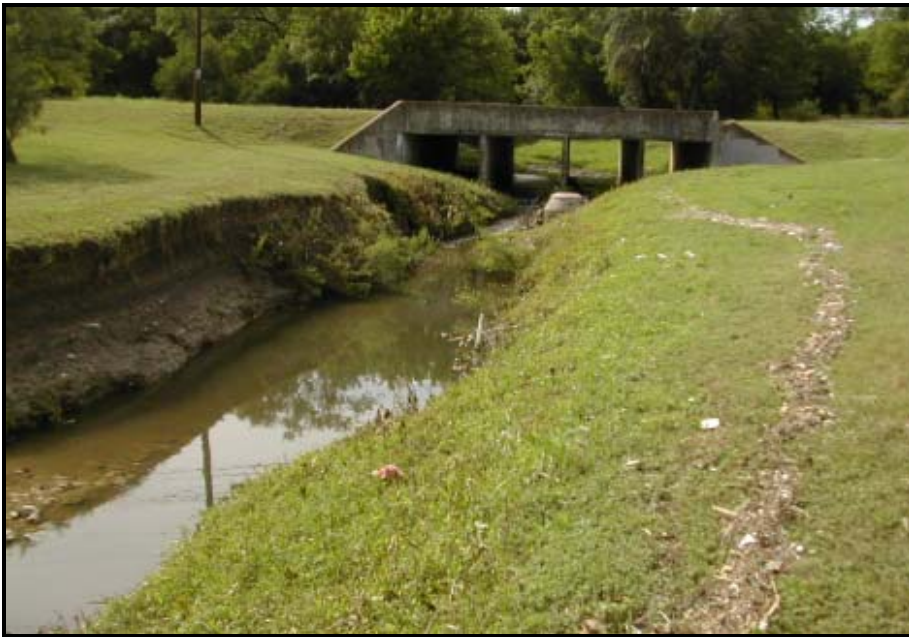
Tannehill Branch in Bartholomew Park showed evidence of severe bank erosion before restoration in 2003 (i.e. Figure C-1). In addition to steep, unstable banks, this reach exhibited signs of downcutting (Figure C-13) and gully erosion (Figure C-15), all of which degraded the appearance of the park (Figure C-17) and minimized recreational opportunities (Figure C-19) in the park. Comparison of photographs from 2003 with current photographs suggests that the restoration features installed in 2006 have improved stability of the banks (i.e. Figures C-5 and C-6) and minimized downcutting (Figure C-14). Deposition has occurred in the gullies but headward erosion continues toward the road parallel to the park (51st Street, Figure C-16).

Figure C-1. Tannehill Branch in Bartholomew Park facing Berkman Drive before restoration, 2003 (Courtesy M. Rotar).

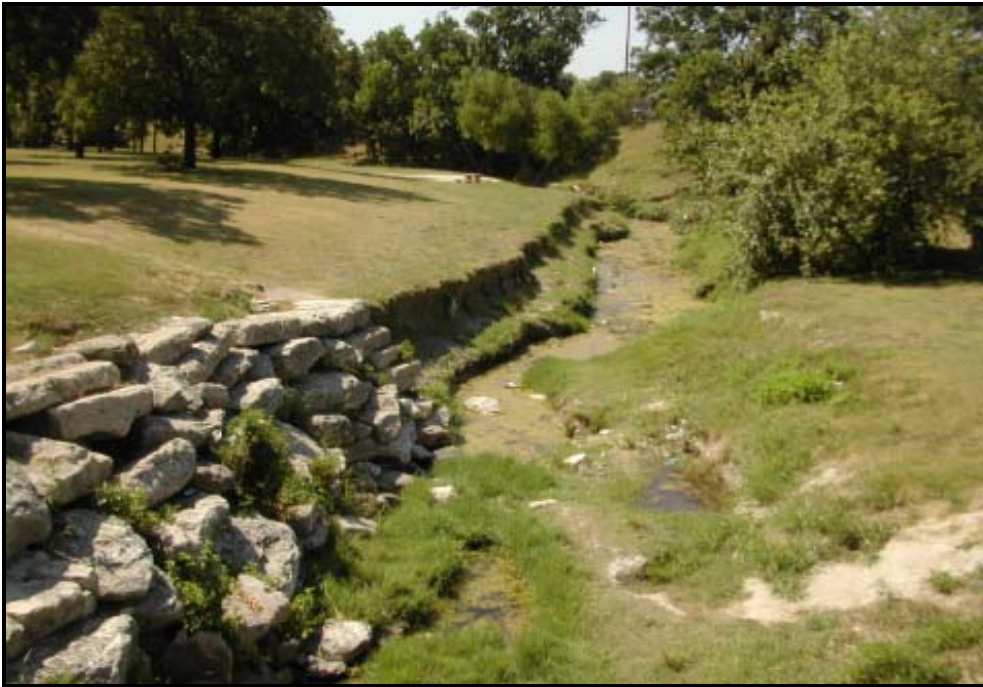
(Figure 10) or staked geotextile fabric (Figure 13) planted and seeded with native vegetation. Limestone boulders used in previous bank stabilization efforts (Figure C-11) were not altered during restoration. Stabilization of the channel bed consists of limestone boulders used for toe protection (Figure 3) and grade control (Figure 4). Only one small segment (~20 m) of the channel in a tight meander bend in the older restored section of the park was stabilized using the traditional method of rock filled gabion baskets (Figure 27).

Figure C-11. Tannehill Branch in Bartholomew Park facing downstream of pedestrian bridge before restoration, 2003 (Courtesy M. Rotar).

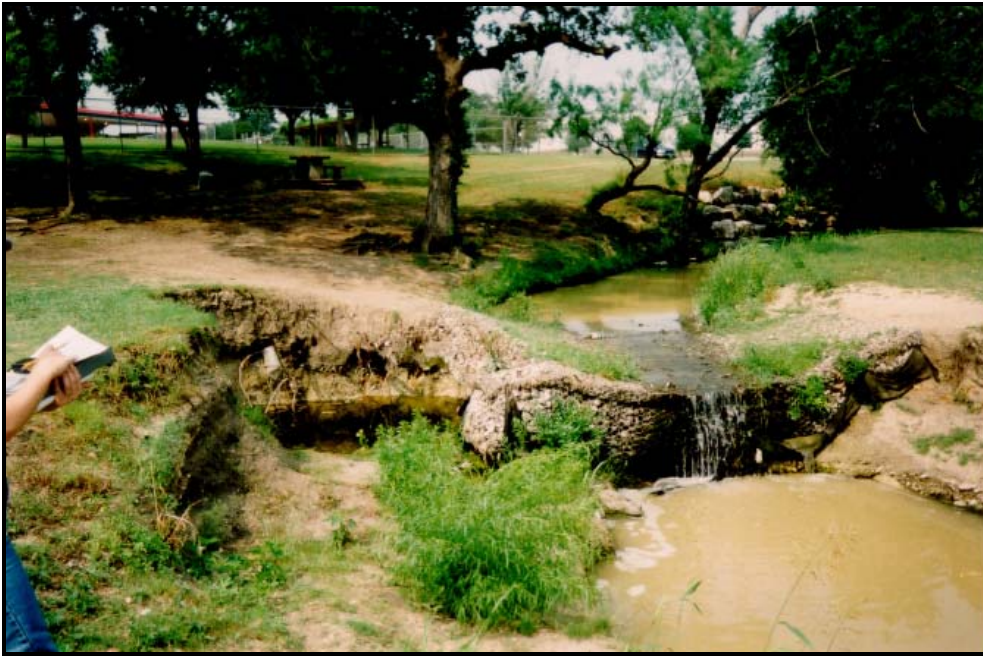
Figure C-13. Tannehill Branch in Bartholomew Park facing southwest towards swimming pool and parking lot on 51st Street before restoration, 2003 (Courtesy M. Rotar).

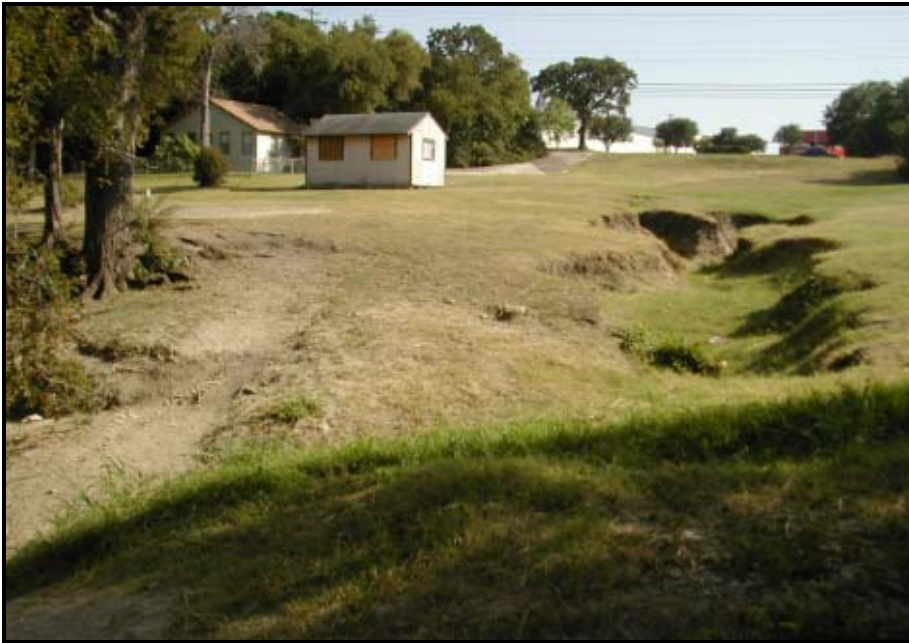
Figure C-15. Head cut gully entering Tannehill Branch in Bartholomew Park east of white buildings before restoration, 2003 (Courtesy M. Rotar).

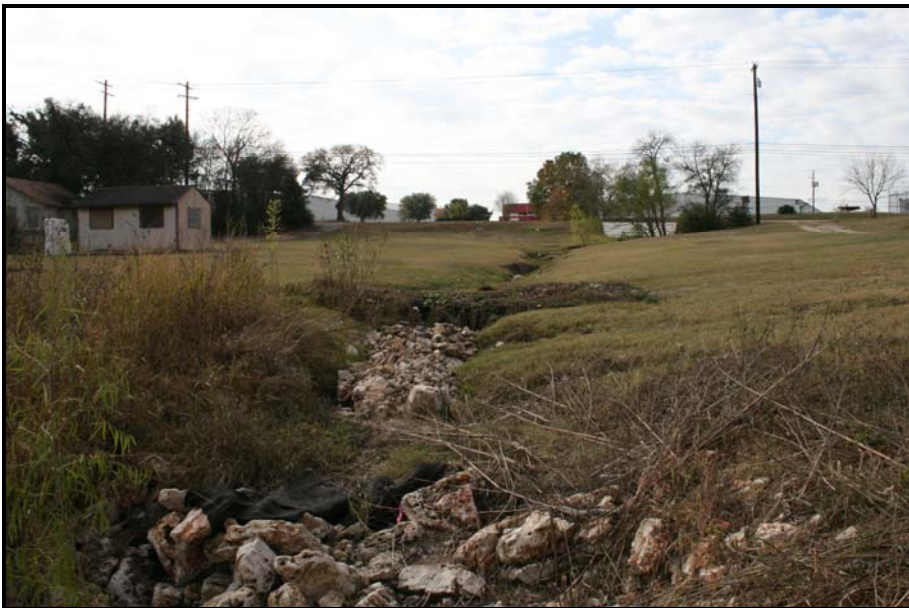
Figure C-16. Head cut gully entering Tannehill Branch in Bartholomew Park east of white buildings after restoration, 2007.
